# **Navajo Abandoned Uranium Mine**

## **Site Screen Report**

### **NA-0318 AUM Site**

**March 2010**

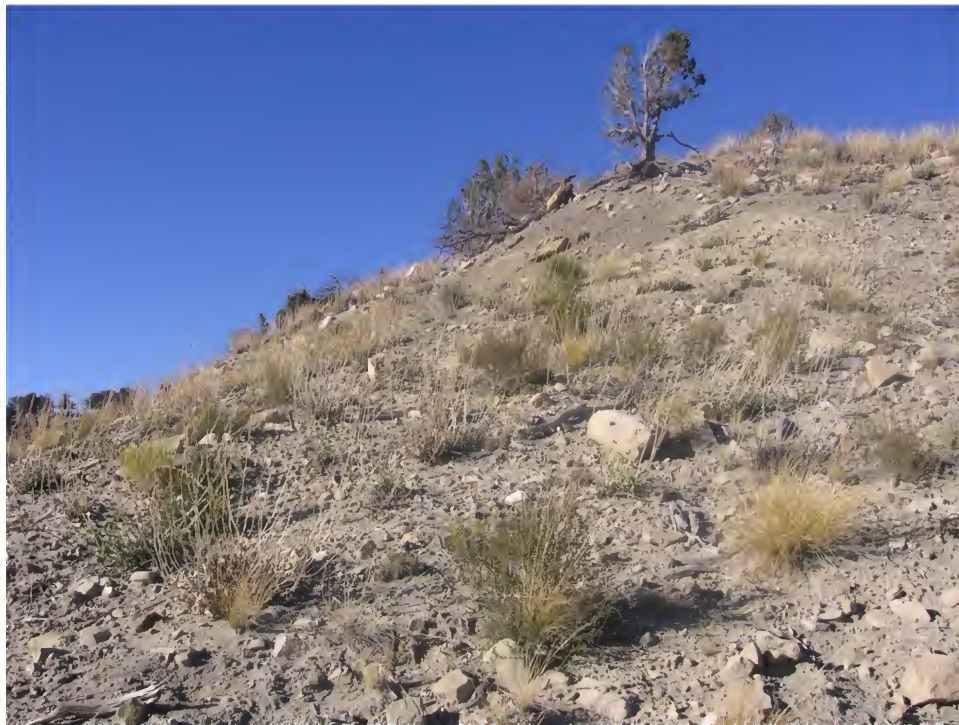
Photo 2. Down slope waste debris

Waste pile at E-SE portion of site on slope, 60 - 70 ft wide and 100 ft long (down slope), with a total estimated volume of 1,296 yd<sup>3</sup>

Unreclaimed waste pile
